**DEPARTMENT OF TRANSPORTATION****DIVISION OF ENGINEERING SERVICES**

Contract #: 04-0120F4Cty: SF/ALA Rte: 80 PM: 13.2/13.9File #: 69.28**WELDING INSPECTION REPORT****Resident Engineer:**Pursell, Gary**Address:** 333 Burma Road**City:** Oakland, CA 94607**Report No:** WIR-003480**Date Inspected:** 08-Jul-2008**Project Name:** SAS Superstructure**OSM Arrival Time:** 1400**Prime Contractor:** American Bridge/Fluor Enterprises, a JV**OSM Departure Time:** 430**Contractor:** Zhenhua Port Machinery Company, Ltd (ZPMC), Changxing Island **Location:** Shanghai China

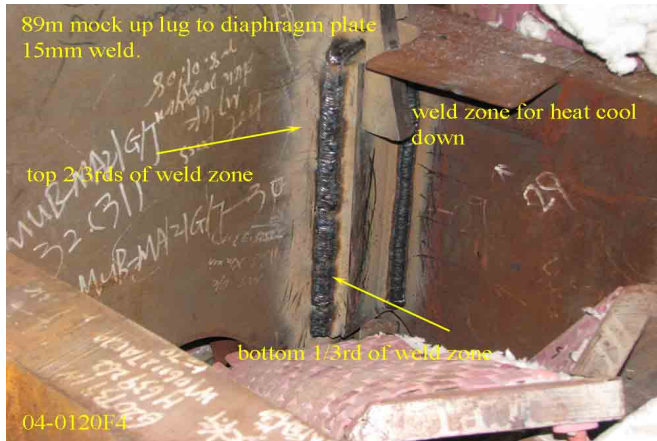
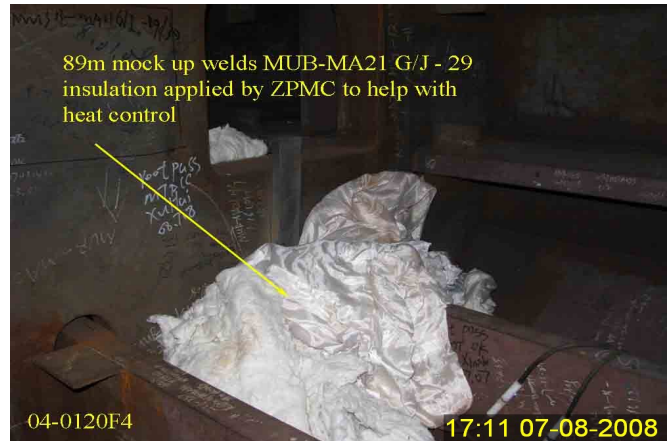
This QA inspector was called by ZPMC QC personnel Ken Zhang to be informed that ZPMC had completed the welding of Lug plate to Diaphragm for the 89m mock up and was starting the controlled cool down. Upon arrival at the 89m mock up it was noted that ZPMC had placed insulation at the weld area and the heater blocks were on. This QA inspector spoke with ABF personnel Jeff Chan and Yang Yiheng and was informed of the following information; ZPMC had welder Li Mengqian performing the welding operation using the SMAW process under WPS-B-T-4113-2 and preheat and interpass temperatures were within the required ranges for welding. It was also noted that ABF had witnessed the root pass and Magnetic Particle (MT) inspection by ZPMC and had accepted

this weld. ZPMC then proceeded to weld the interpass and cover passes for this location through competition. Once the weld was completed ABF and ZPMC used a temperature indicating marker (Temp-Stik) of 180°C to start the controlled cool process at 1653 hrs. During the time this QA inspector was at this location the following readings taken by ZPMC QC inspector. The locations for the low readings were at the bottom 1/3 of the weldment approximately 100 to 150 mm from the bottom as follows;

The locations for the low readings were at the bottom 1/3 of the weldment approximately 100 to 150 mm from the bottom. The top 2/3 of the weldment were as follows 1728 hrs – 180°C and 1753 hrs – 147°C. With the bottom 1/3 it does show a drop of more than 40°C in a one period which is beyond the requirements of the approved submittal. ZPMC's QC inspector was onsite to perform the monitoring. The established ambient temperature was approximately 30°C taken at the 89m mock up.
